Project Spotlight

Coney Island Subway Station: Micropiles with Aerlite Void Fill

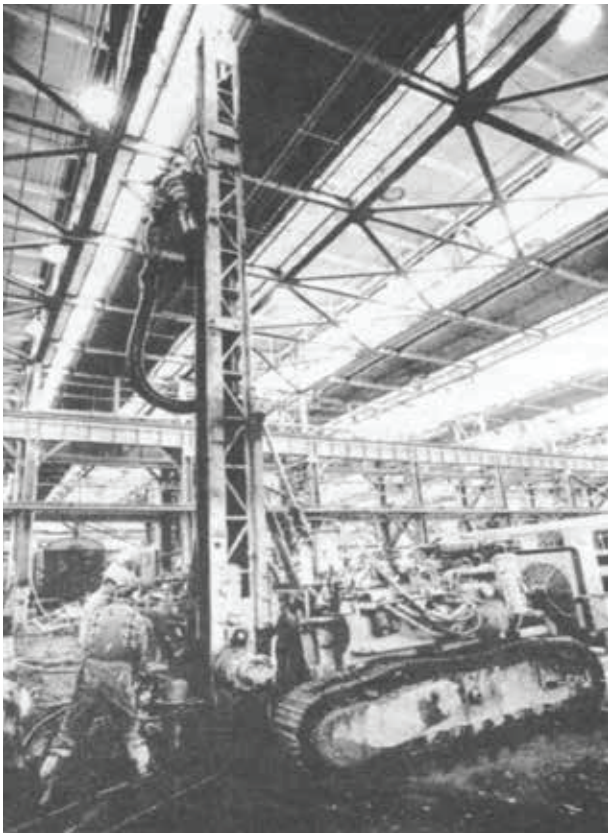
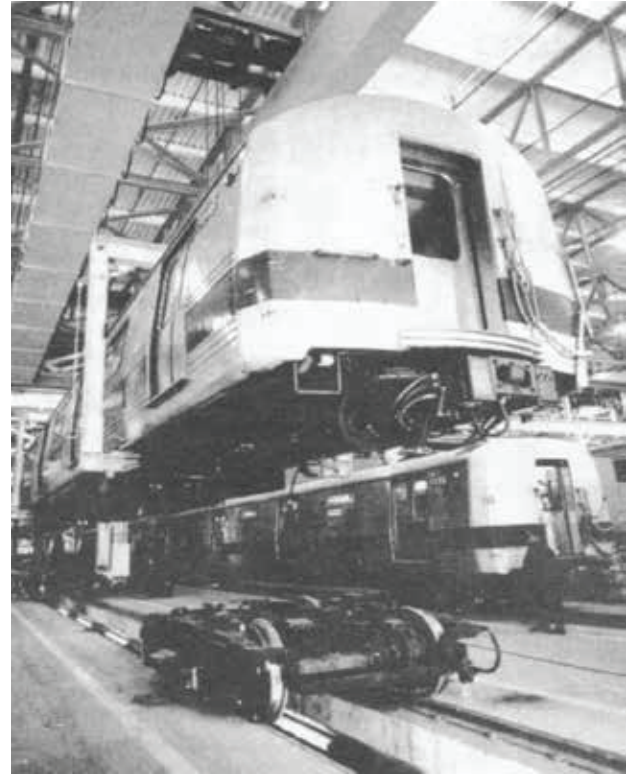
The repair plan included the installation of micropiles to stabilize the maintenance building, Low-Density Cellular Concrete (LDCC) to fill existing voids under the floor slab and several new structures and equipment.

The micropiles, small diameter piles made with high-strength steel casing and/or threaded bar, are designed to resist compressive, tension, and lateral loads. 6-7 inch diameter piles, installed to depths of 35 feet were designed to support loads up to 30 tons. The piles were successfully installed without disrupting shop operations during construction.

Existing voids under the floor slab were filled with Low-Density Cellular Concrete produced using Aerix™ AERLITE foaming agent. The 30-36pcf material was pumped into the voids without removal of the floor slab.
