Project Spotlight

NC72 Bridge, Fayetteville, NC

Owner: North Carolina DOT
Installer: UMA, Geotechnical Construction, Inc.

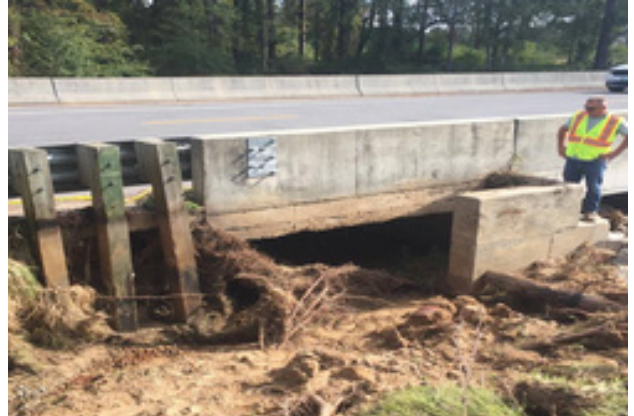
With more than 12,000 bridges across the state of North Carolina, the state's Department of Transportation (NCDOT) has its hands full maintaining these structures and making sure that its residents and visitors have safe passage to their destinations. When the flood waters from Hurricane Matthew washed out a NC-72 bridge outside of Fayetteville, NCDOT needed a quick solution that would ensure long-term stability in extreme weather.

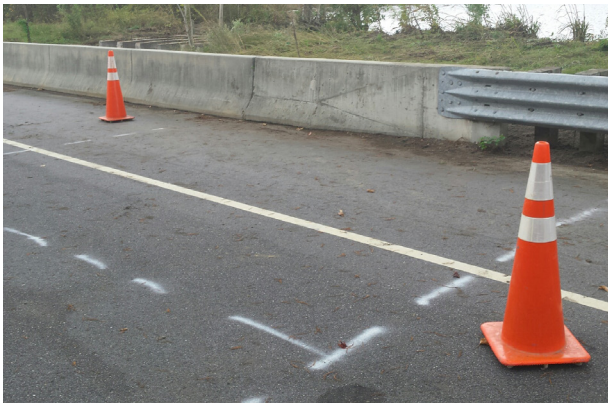
The soil underneath the NC-72 bridge washed out, leaving a void of 900 cubic feet that had to be filled with a material that would prevent future soil washouts, while also providing high compressive strength and stability. The team from UMA, Geotechnical Construction, Inc. chose to use Aerix's AERLITE™ non-permeable low-density cellular concrete (LDCC) as the fill material underneath the bridge.

The three-person installation crew from UMA, Geotechnical Construction, Inc. completed the AERLITE™ installation in just three hours, using ready-mix trucks to hold the concrete slurry and then adding the AERLITE to complete the cellular concrete mix. The void underneath the bridge approach was completely filled and stabilized with only 35 cubic yards of low-density cellular concrete.
